On some AMT12's, a clicking noise may develop that radiates from the upper front pivot arm. **See Diagram 1.** The clicking noise may be the result of the flat belt cam not fully secured to the front arm shaft.

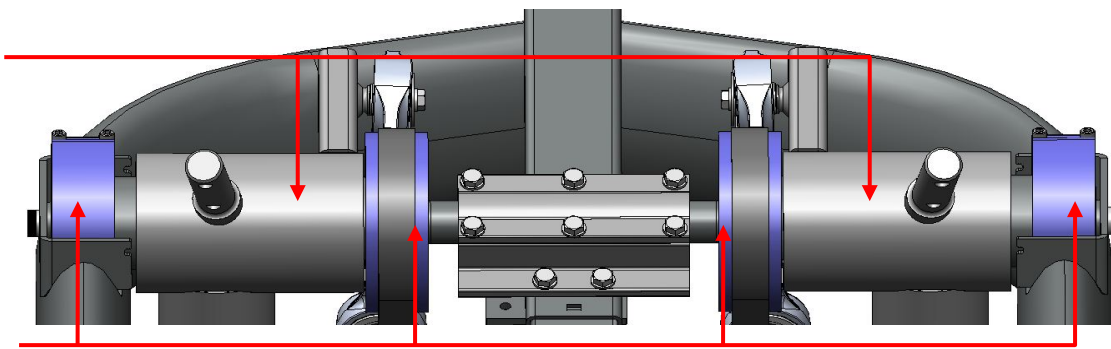
Diagram 1

Front Arm's

Flat Belt Cam's

If the flat belt cam is loose on the front arm shaft, first, try tightening the flat belt cam clamp screws. The screws should be torque to 120 inch pounds. If tightening the screws does not fix the clicking noise, the flat belt cam clamp shim should be replaced. Order the AMT12 Cam Shim Kit, part number PPP00000058041101. The shim replacement kit will include four shims and installations instructions.
