**Products Affected:**

DPL305 Pulldown (Serial code BMGP, BJAP) built prior 1/22/2013.

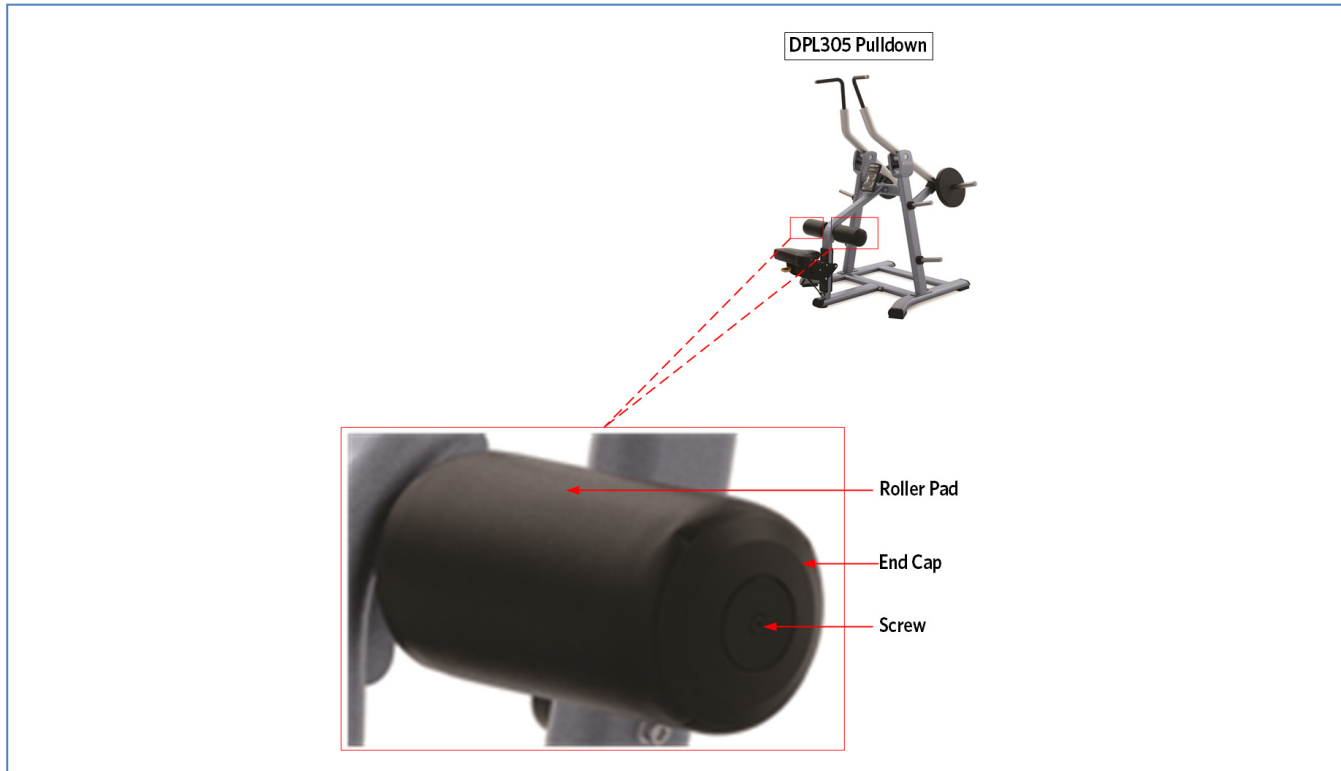
**Diagram 1**

The screw that holds the end caps are coming loose and falling out. **See Diagram 1.**

The roller shaft on units built prior to 1/22/2013 are too short. The short roller shaft causes the round end caps and screw to spin along with the roller pads normal rotating movement, forcing the end caps to become loose and fall out.

The length of the roller pad shaft has been increased to eliminate the issue. If the DPL305 is exhibiting the symptom order and replace the revised shaft, PN PPP000CWP020900101.
