EFX600/700/800 generator grounding procedure

EFX600/700/800 units built prior to 2/7/2019.

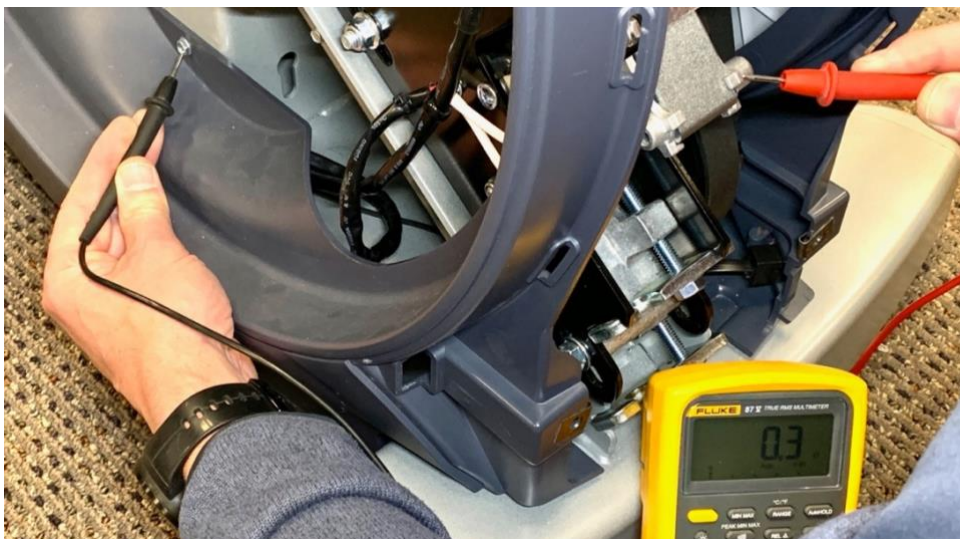
Unit may operate at maximum or minimum resistance due to a damaged LPCA. The LPCA can be damaged by electrostatic discharge (ESD) from improperly grounded drive belts.

1. Remove the two screws on the drive access cover and remove the cover. See [Drive Access Panel Replacement](#).
2. Remove left side drive disk cover. See [Drive Disk Cover Replacement](#).
3. With the unit fully powered down, use a multimeter set for resistance to check the continuity from the frame of the electromagnet on the generator to the to the drive cover mounting screw. **If the resistance is over 10 ohms, continue to the next step.**
