## Service Bulletin

Discovery Plate Loaded Strength Machines

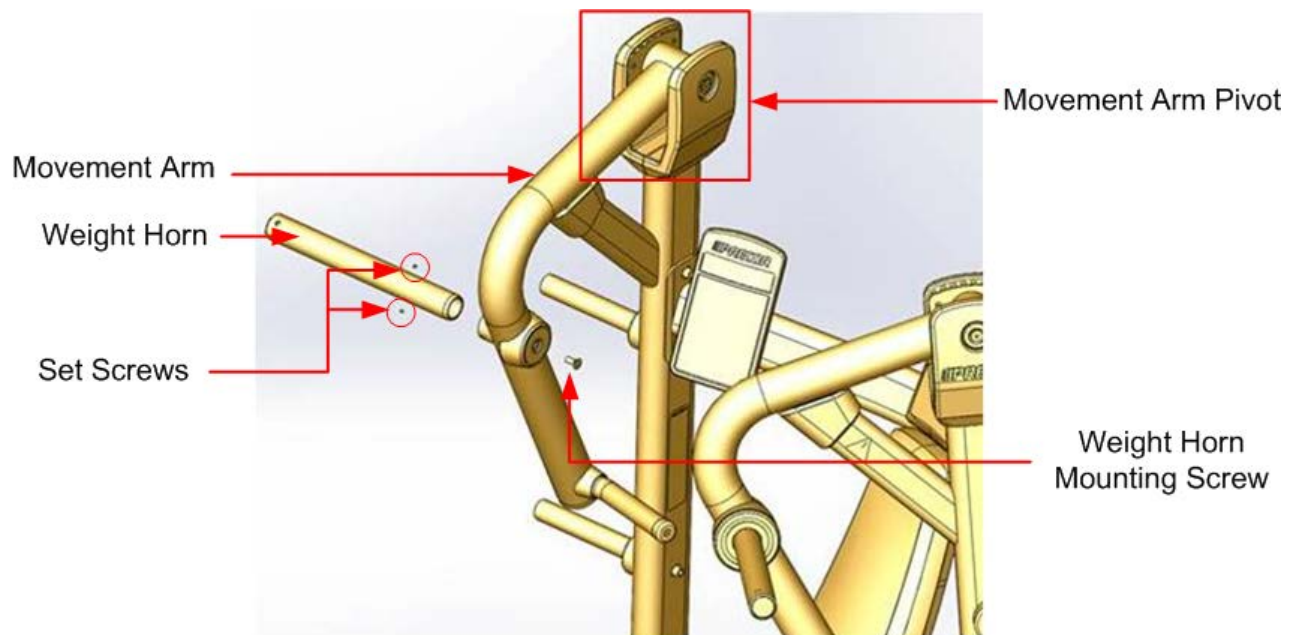
**Diagram 1**

There is the potential for a squeaking noise to develop from the Movement Arm. **See Diagram 1.** The noise is commonly misdiagnosed as radiating from the Movement Arm Pivot. **See Diagram 1.**

In most cases the squeaking noise is actually radiating from a loose Movement Arm Weight Horn. When weight is applied to a loose Weight Horn and the Arm is in motion the Weight Horn will rotate in its mounting location, causing the squeaking noise. **See Diagram 1.**

If the described symptoms occur, remove the two Weight Horn set screws and the Weight Horn Mounting screw, apply blue Loctite 243™ to all screws. Fully tighten the mounting screw first, then the set screws. Repeat the process for the remaining Movement Arm Weight Horn.
