DSL 505 PECK FLY/REAR DELT SECONDARY STOP-PIVOT UPGRADE

Mode: DSL505 Rear Delt/Pec Fly

Mfg. Date: units prior to May 03. 2016

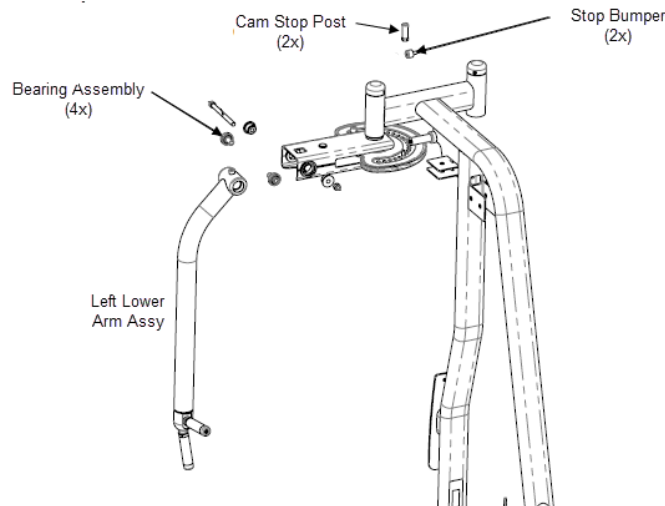
1. The cam stop posts only contact one half of the stop bumper causing premature bumper failure allowing the pivot arms to strike the main frame damaging the paint.
2. The specified secondary pivot bolt torque was not sufficient to securely clamp and hold the pivot arm bearing in position.

Replace stop posts with new longer stop posts that provide full bumper contact and increase the pivot bolt torque setting.

The installation instructions for this repair are included with kit CW50300-101 (PPP00000CW50300101). This service bulletin replaces the Stop Bumpers (2x) and the Secondary Pivot Arm Bearing Assemblies (4x).
