AMT LPCA vertical sensor

AMT12 Open Stride units

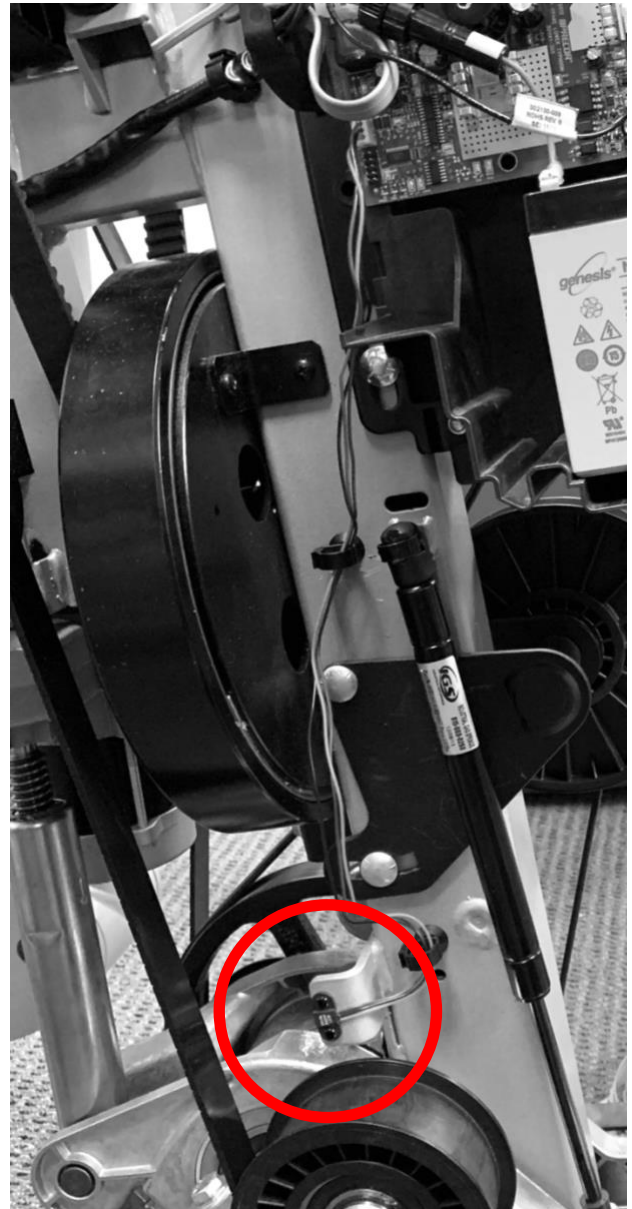
Figure 1: Vertical sensor

If there is an issue with the vertical stride sensor (see Figure 1), Error 62 will be displayed. The most likely cause of this will be a faulty, broken, or poor cable connection at the lower PCA. A missing or reversed magnet on the crank arm is also a possibility, as is a defective sensor. Least likely but possible is a fault on the lower PCA.

- On AMT12 Open Stride units **prior to 10/18/2018**:
If Error 62 is displayed and the vertical sensor is the problem, the vertical sensor should be unplugged and removed. Next, a jumper will need to be placed across pins 2 and 3 of the J8 connector, which will stop the reporting of the error.

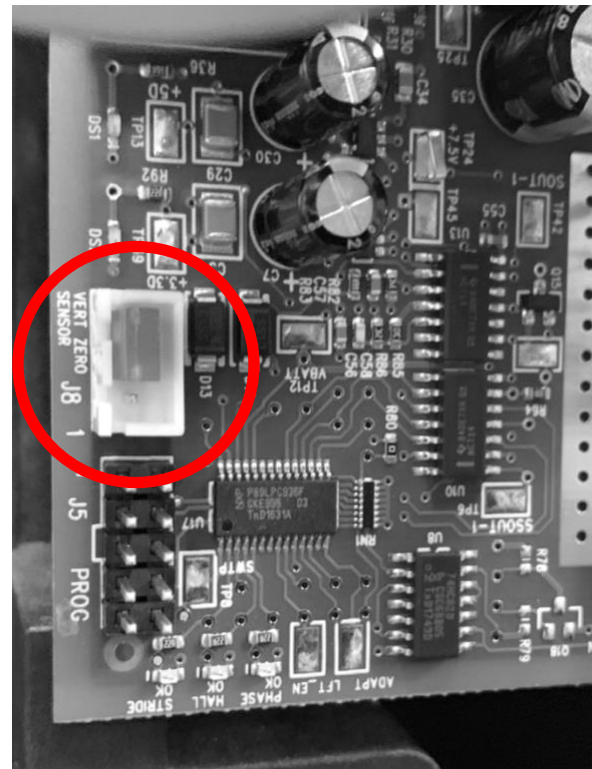
Figure 3: Vertical sensor jumper installed (pin 1, bottom, is left open)
