Improperly installed treadmill side rail trim causing noise

Consumer treadmills models C9461 , C9321 , and TRM 400,

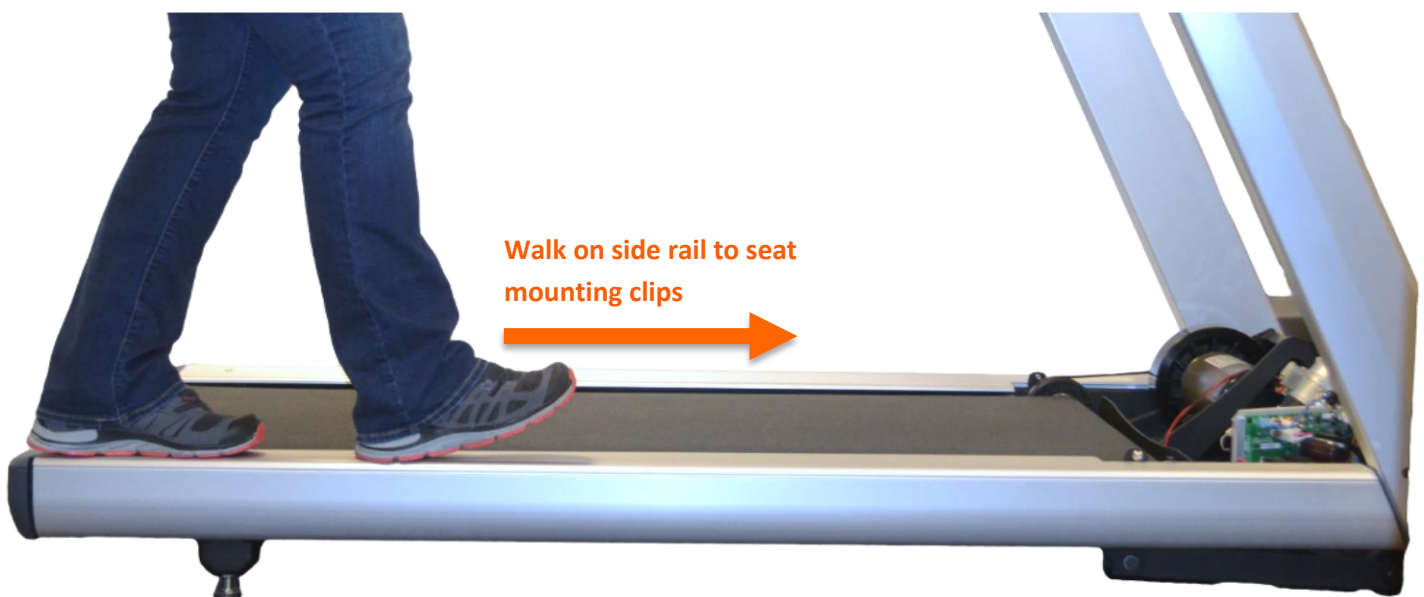
The side rail trim is secured to the treadmill frame by fasteners and molded side rail clips. If during assembly these clips are not fully engaged, they cause the side rail to become high centered. Stepping on an improperly installed side rail trim will produce a creaking sound.

Re-install the side rail trim to seat mounting clips properly onto the treadmill frame.

- 1 Remove the hood
- 2 Remove the end cap
- 3 Remove the right and left side rails
- 4 Place the right side rail onto the mounting clips and hand tighten the fasteners
- 5 Tighten the rear fastener to 90 in-lbs (10.2 N-m)
- 6 Step onto the back of the side rail and walk to the front to correctly engage and seat the mounting clips
- 7 Tighten the front side rail fastener to 30 in-lbs (3.4 N-m)
- 8 Repeat procedure for the left side rail
- 9 Verify that no noise is audible when stepping onto either side rail trim
