Treadmill Lift Motor Actuator Upper Mount Noise Repair

All TRM 800.v2 series treadmills

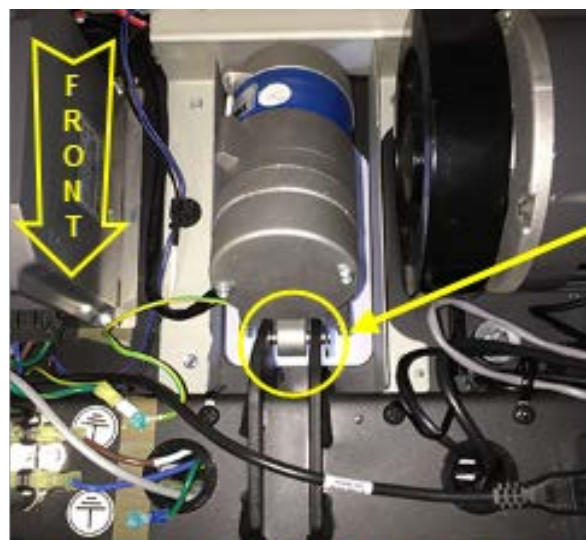
Upper Lift Motor Actuator Housing Clevis Pin

Noises due to surface galling between the upper lift motor actuator aluminum housing and the zinc plated steel clevis pin.

- 5 Clean any debris/dirt and apply a light coat of synthetic grease to the inside of the upper lift motor actuator housing clevis pin mounting hole.
- 6 Clean and apply a light coat of synthetic grease to the clevis pin.
- 7 Reinstall the upper lift motor actuator. Replace the clevis pin and secure with the hitch pin.
- 8 Connect power and switch the power ON.
- 9 Remove support blocks from under the frame.
- 10 Verify treadmill incline operation and return to service.
