## 608 squat rack stabilizer plate upgrade

Affected Serial Codes: BB89, BDBR, BKPR, BGHR

Affected Mfg. Date Range: 6/2007 to 11/7/2015

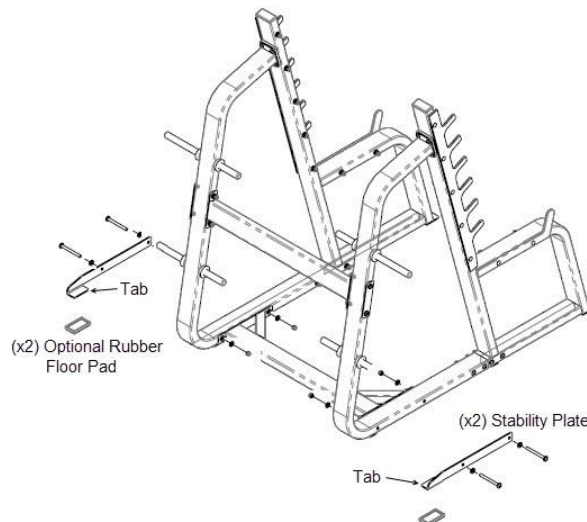
- 1 Remove the left backing plate and discard. Retain all fastener hardware for installation.
- 2 Install the new left stability plate (PPP00000CW39211101). Reuse the retained fasteners.
- 3 Torque to 75 ft-lb (102 Nm).
- 4 Repeat process and install the right stability plate (PPP00000CW39211102).
- 5 If the unit is not equipped with the rubber floor pad option, discard the two pads included with the kit. If the unit has the rubber floor pad option, install the two new pads (PPP00000CWAC1180101).
