TRM800.v2 Take Up Roller Adjustment Bolts Seizing

Product: TRM 800.v2 Experience series treadmills

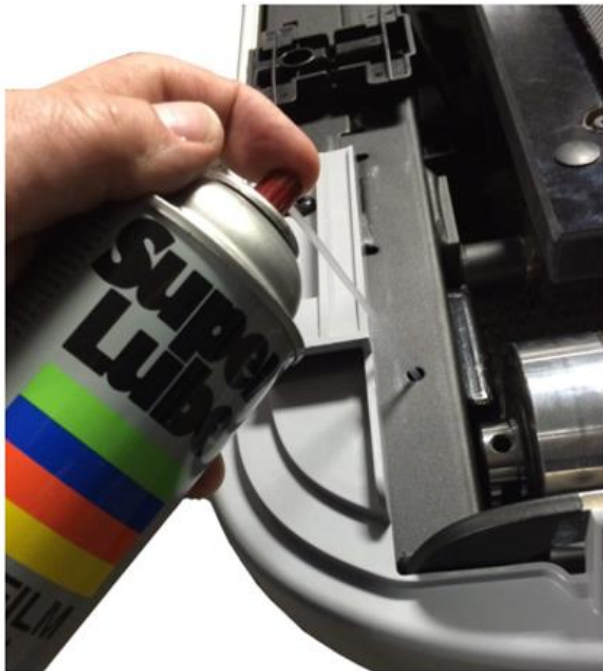
Apply lubricant through the frame rail access hole.

- 1 Prior to loosening or adjusting the take up roller adjustment bolt, apply a coat of Super Lube lubricant (or equivalent) to the bolt.
 - a Locate the small hole located on the frame rail directly above the take up roller cassette.
 - b Apply a heavy coat of lubricant through the frame hole onto the take up roller adjustment bolt.
 - c Loosen or make adjustments to the take up roller adjustment bolt

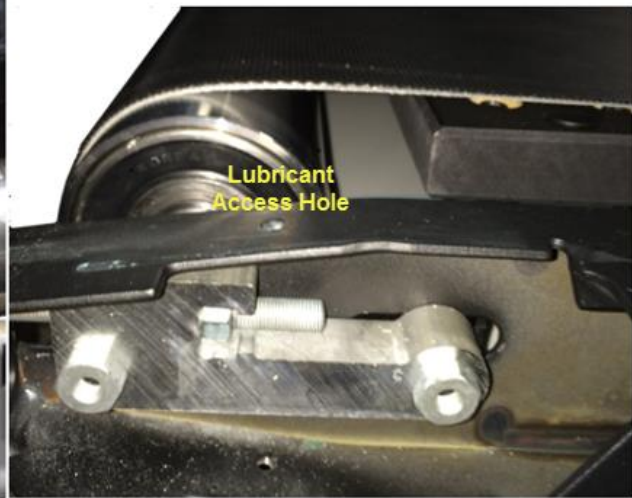
Rear Roller Adjustment Extrusion

The take up roller adjustment bolt can seize when loosened for adjustment or removal causing damage to the adjustment bolt and the rear roller adjustment extrusion. If the bolt seizes, you will need to cut the head off the bolt and remove the rear roller adjustment extrusion.
