AMT12 reduction (step-up) pulley replacement

Make: AMT12 Series Fixed Stride and Open Stride Adaptive Motion Trainer
 Model: 813, 823, 833, 835, and 885
 Mfg. Date: Units manufactured prior to Feb 2, 2015

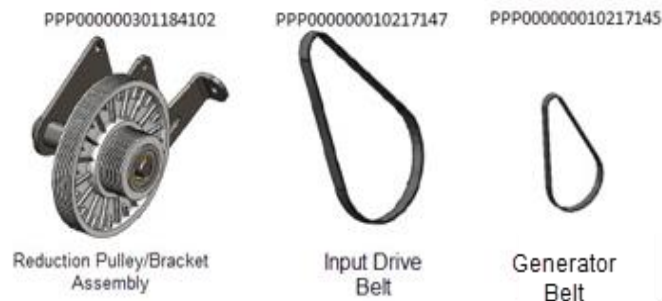
Parts Included with Kit 58112-102 (PPP00000058112102)

QTY	Part Number	Description
1	PPP00000058112102	KIT, REDUCTION PULLEY, AMT12

This service bulletin installs Kit 58112-102 (PPP000000058112102) which replaces the reduction (step-up) pulley/bracket assembly, the generator belt, and the input drive belt.
