# P30 console machine control malfunction repair (errors 80 - 83)

Product: P30 consoles

Mfg. Date: units prior to 8/17/2015

SB.TRM.20150810 rev02

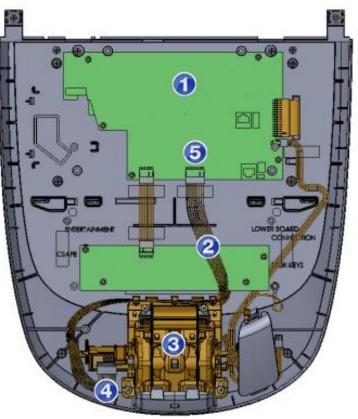
Number	Description
1	Upper PCA
2	Machine Control Cable
3	Machine Control Assembly
4	Machine Control PCA
5	Upper PCA Machine Control (J4) Connector

- 1 Remove power from the base unit.
- 2 Remove the P30 from the base.
- 3 Remove the P30 top cap rear cover, the HR access door, and the console access panel.
- 4 Disconnect the HR board connector and remove the rear cover.
- 5 Disconnect the machine control cable connector from the machine control PCA connector. Apply dielectric grease into each female pin of the machine control cable connector housing. Wipe excess grease from the connector housing and reconnect. Attach connector so that the yellow wire aligns with pin 1 of the PCA connection.

- 6 Disconnect the machine control cable connector from the Upper PCA "Machine Control" (J4) connection. Repeat step 4 and completely fill each female connector housing pin with grease. Wipe excess grease from the connector housing and reconnect. Attach connector so that the yellow wire aligns with pin 1 of the PCA connection. Reapply the cable routing Kapton tape.
- 7 Replace the removed console covers. Make sure to reconnect the HR cable connector.
- 8 Reinstall the console onto the base unit.
