CW-113 Adjustable Decline Bench Pivot Bolt Replacement

Icarian CW-113 Adjustable Decline Bench

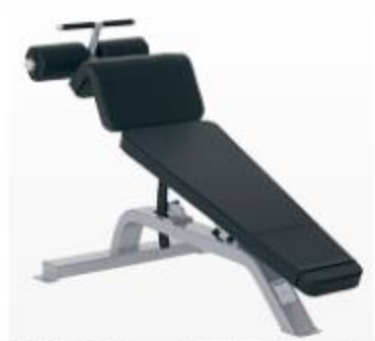
CW-113 Adjustable Decline Bench

The back support to main frame pivot connection may become loose. The pivot bolt torque specification was not large enough to keep the connection tight during extended use.

Replace the existing button head bolt with a new socket head bolt allowing increased torque capacity (75 ft-lbs (102 Nm)).
